To: Mark Adams, Waste Connection
Cc: Kyle Regan, Randy Tourville
From: Dave Stewart
Date: December 18, 2017
Subject: EM Survey by National GPR Services
Project No.: 4898-001

GEOPHYSICAL EXPLORATION REPORT

County Roads 5 and 6
Erie, Colorado

NGPRS PROJECT NO: 178694

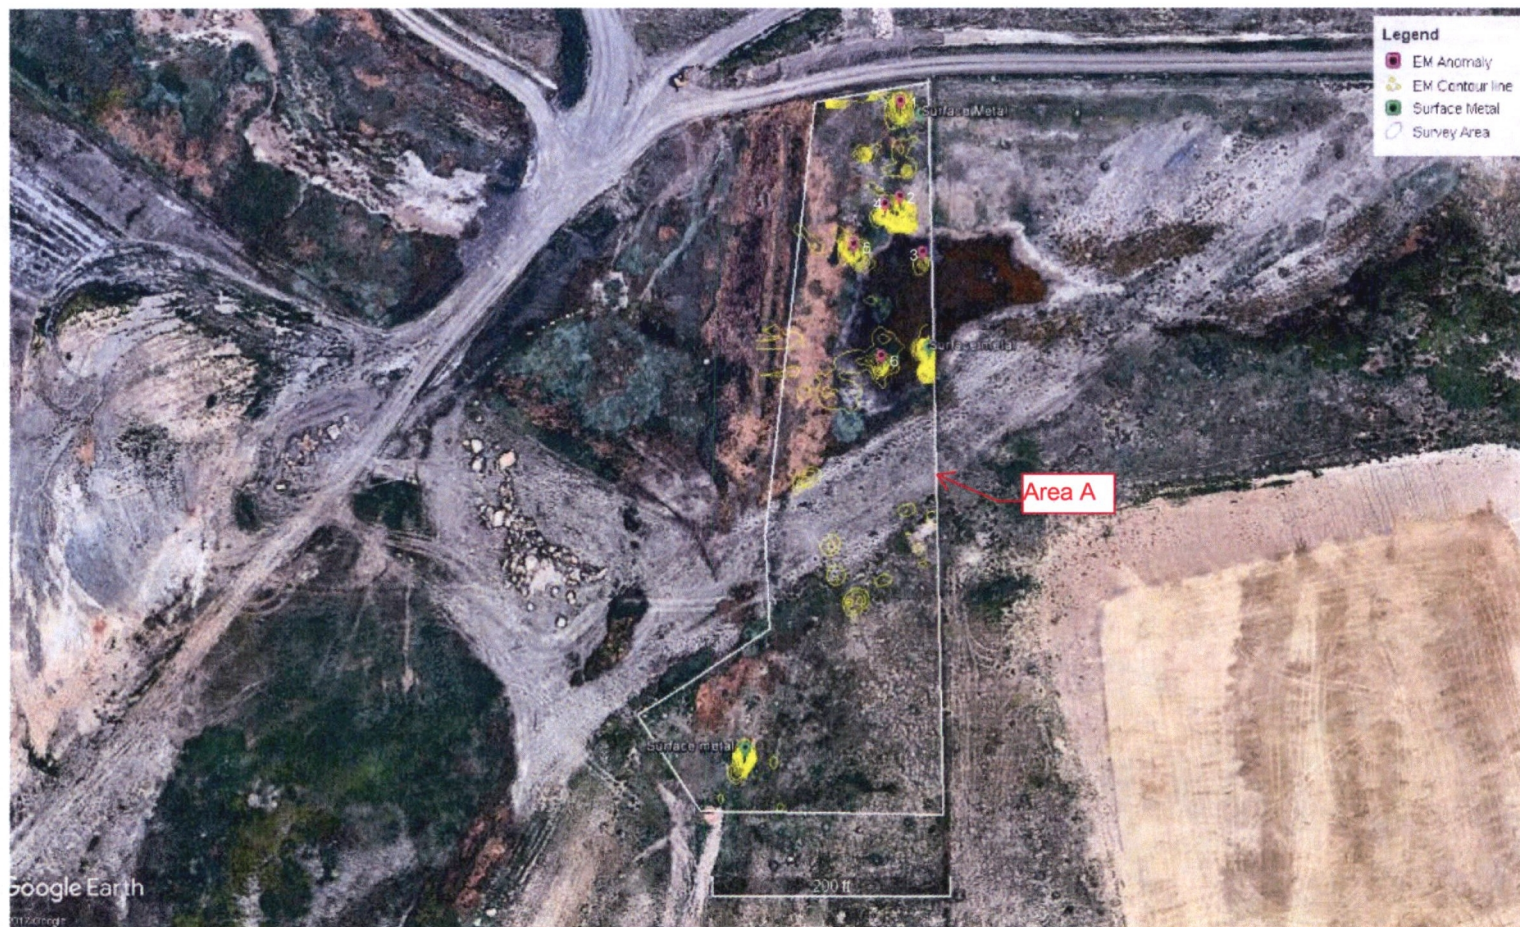
Figure 2 - EM Contour and Anomaly Location Map

The EM61 contour map and anomaly location map for Area A is provided as Figure 2. The findings of the EM61 survey are summarized below:

- A good correlation of the processed EM61 data and the field observations of site conditions and buried targets in the survey areas was achieved.
- Area A results indicate six (6) EM anomalies, shown in pink on Figure 2, were identified with a EM response magnitude that could represent a potential drum(s) or other metal target(s) having a similar mass as a drum. Table 1 provides a list of the EM anomaly location coordinates.

- Area A results also identified three (3) surface metal areas, shown in green on Figure 2, from former dumping or site features (e.g., fencing). These surface metal areas contributed to high magnitude EM responses, as shown on Figure 2. Several smaller magnitude EM responses across the survey area are likely due to smaller buried metal targets and debris.

There were six (6) areas that NGPRS found that warrant additional investigation. These are identified on the Figure 2 as the "pink" dots. There were three (3) additional areas on the report that are identified in "green dots". These areas have a response but are likely due to surface debris.

Based on previous experience with CDPHE, I would suggest that you coordinate with Curt Stovall and provide test pits for the pink dot areas. One of the requirements will be that you provide a certified asbestos individual to make sure that when digging the test pits, you don't expose the area to asbestos. I assume you have someone in house to provide that service? If not, we can arrange for this to happen.

- EM anomaly identification will require excavation to confirm the presence of drums at the six (6) EM Anomaly locations identified in this report.

- We recommend that the EM target locations identified be confirmed using test pit excavation or soft-dig (vacuum excavation) methods.

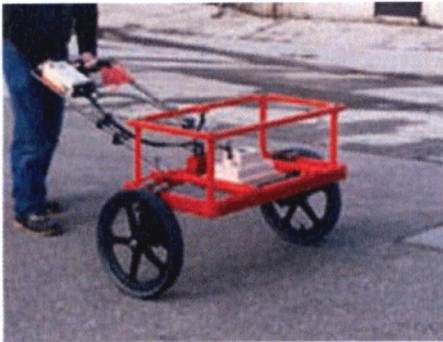
The Geonics EM61-MK2 Metal Detector provides multiple measurements of the decay of the secondary magnetic field associated with any metallic object. Data available from as many as four time gates – geometrically spaced in time from 216 μs to 1,266 μs – provide recognizable improvements in both detection and characterization.

Data from multiple time gates -- three or four, user-selectable -- are recorded to provide a description of the response decay rate, supporting both the characterization and limited discrimination of targets. Data collection is supported by the DAS70-AR Data Acquisition System.

The system can be pushed or pulled as a trailer, by person or vehicle, as either a single unit or an array of multiple units; for multiple unit configurations, options are available to customize component specifications and layout. As may be required, with the addition of a backpack and associated cable set, the system can be carried by a single person with a belt harness.

A Geonics EM61 MK2 (EM61) was used to explore the property for subsurface metal objects. The EM-61 is a time-domain, high sensitivity metal detector suitable for the detection of both ferrous and non-ferrous metal. The EM61 provides multiple measurements of the decay of the secondary magnetic field associated with any metallic object using up to four (4) time gates (readings spaced from 216 microseconds to 1,266 microseconds). The EM61 was equipped with an Archer data logger and global positioning system (GPS) antenna to record EM61 data and horizontal positioning data simultaneously. Equipment and settings are shown in Attachment 1.

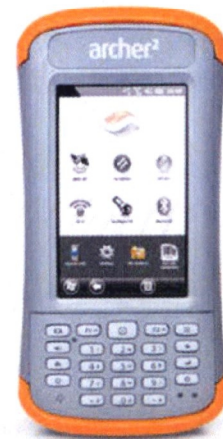
Archer 2™ Rugged Handheld

The Archer is used for data logging processes in the field.

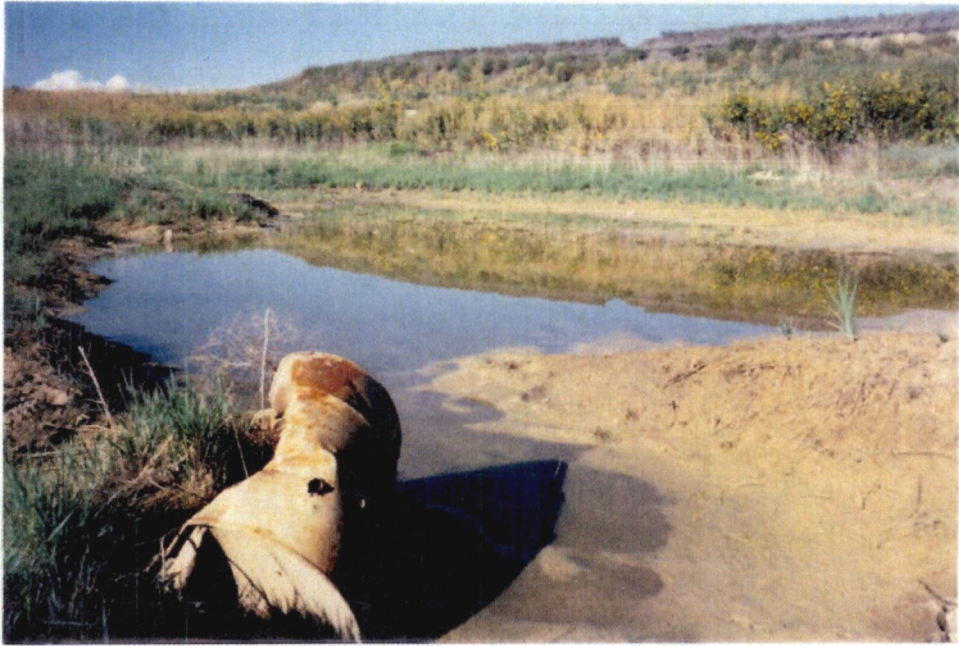
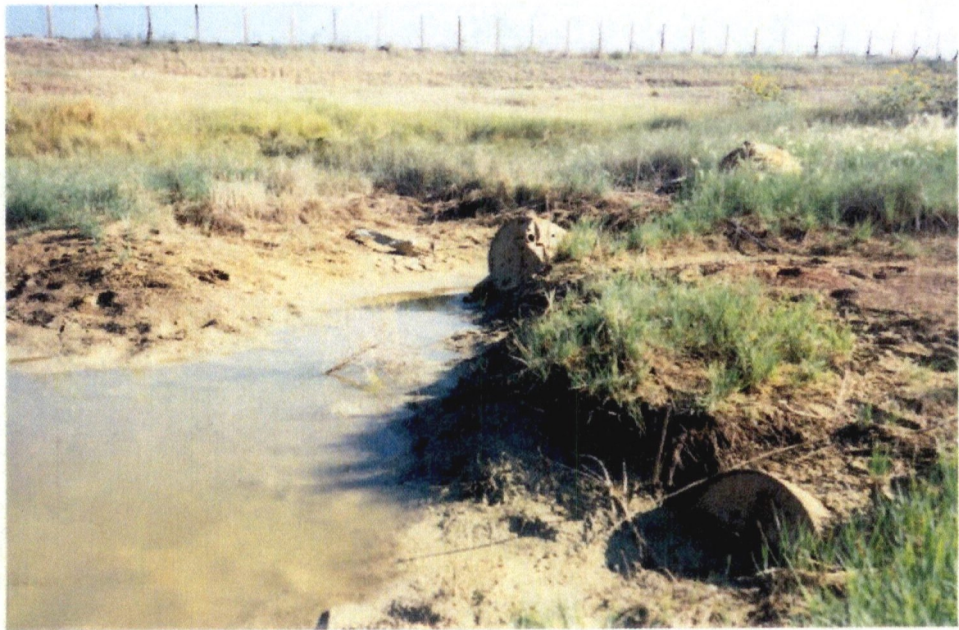
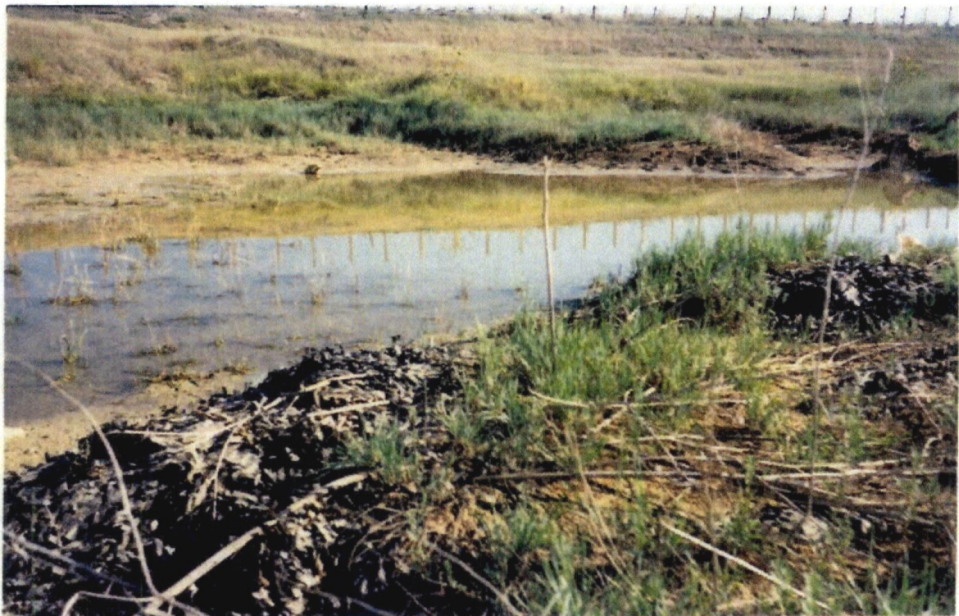
PHOTO 4

Attached for your information is the NGPRS report from the portion of the Neuhauser Landfill that extends onto Waste Connections (WC) property. Please note that the WC anomaly immediately east of anomaly #6 (labeled "Surface metal") is adjacent to your western-most planned test pit (497486 4430143). We believe that this "Surface metal" anomaly, which seems to extend onto Stratus property, may include the drums that were photographed in the summer of 1990 as part of the Revised Preliminary Assessment (RPA). I've attached the photos from the RPA; see the three photos labeled "Photo 4" on PDF page 2.
